ENCHANTED CIRCLE HOME INSPECTIONS

Inspection Report Prepared For:

Inspection Date:
July 15, 2019

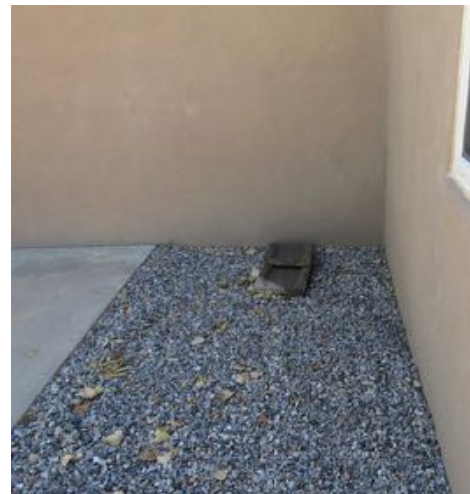
2- The gutter downspout by the front door should be extended 3 feet from the building. ↓

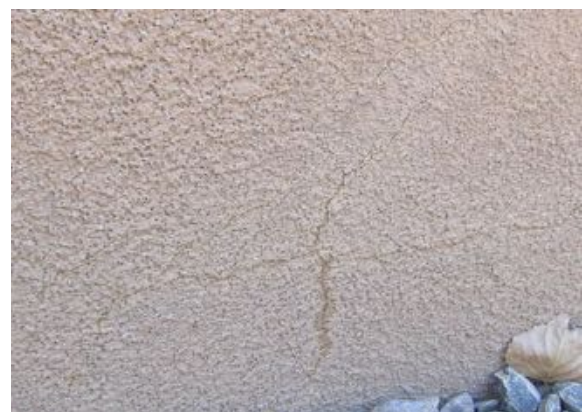
2- Spidering cracks were noted in the stucco finish in areas. This is typical for this surface. You may want to consider having the residence re-color coated in the near future. →

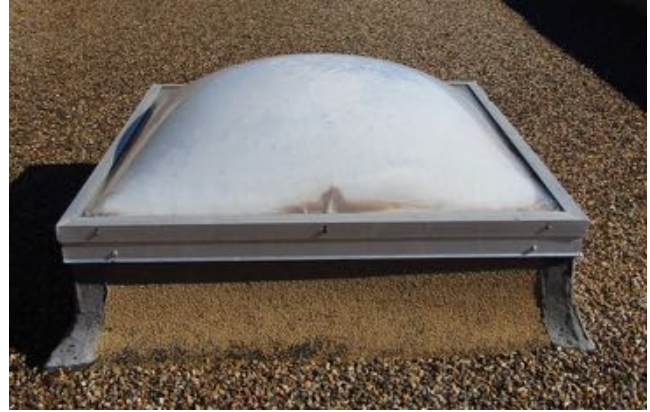
1- The living area skylight dome is cracked. It should be replaced. →

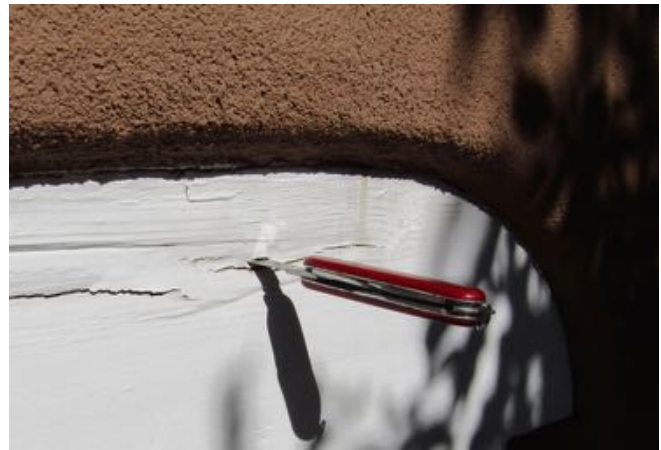
2- Wood rot was noted in the south header in the patio wall window. This should be evaluated and repaired. →

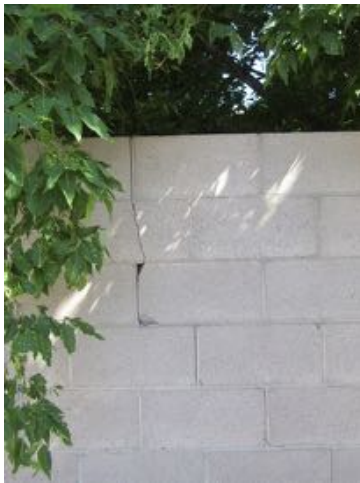
←4- A significant crack was noted in the back-patio wall. It may indicate settling of the foundation. It should be monitored and repaired if needed.

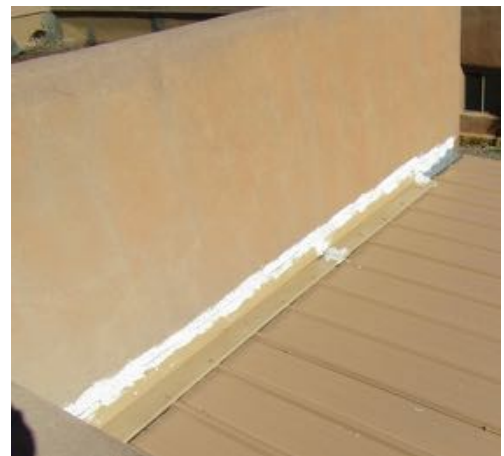
1- The porch roof flashing should be resealed at the wall to prevent leaks. ↘

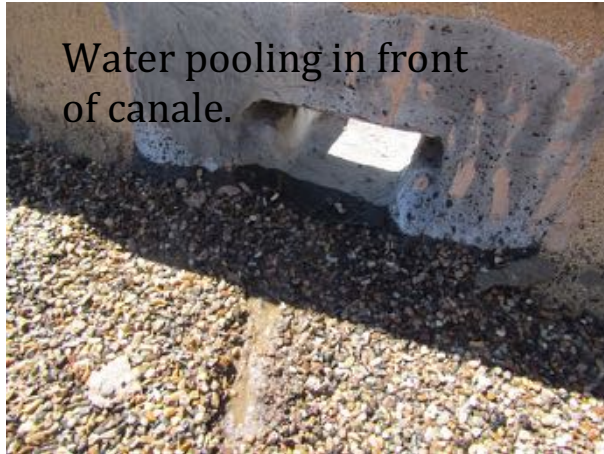
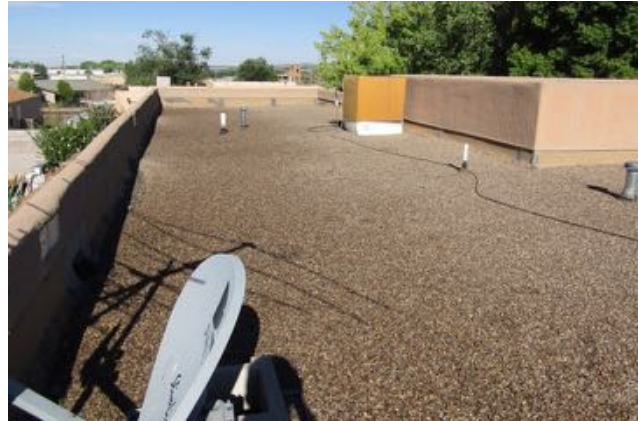
2- The Canales look to be set high and not draining properly. They should be evaluated and repaired by a qualified roofer. ↓

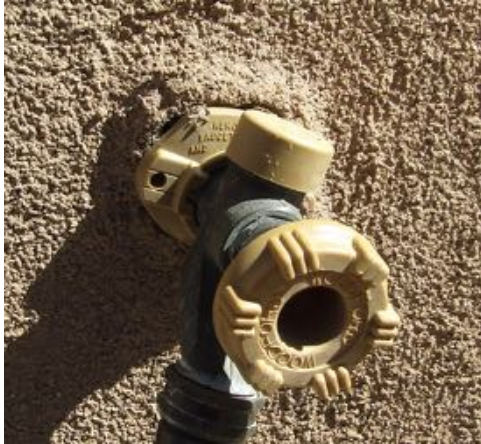
←7- The spigot on the south side of the building is not properly secured to the wall. It should be.

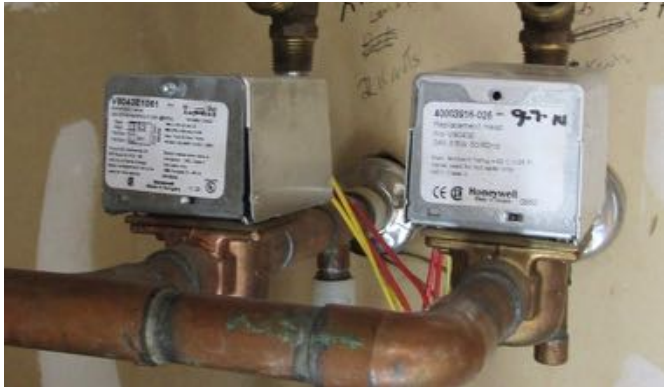
2- The in-floor radiant heating system has two thermostats and two zone valves that regulate the flow of hot water from the boiler to the heating zones. ↓

3- The kitchen and living room zone valve was open despite the zone not calling for heat. It should be replaced.

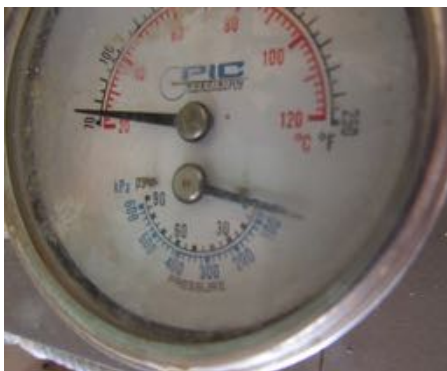
4- The boiler pressure gauge read 0 psi at the time of the inspection. The pressure reduction valve was manually operated. The system was charged to 15 psi.

5- The pressure reduction valve should be evaluated and repaired or replaced by a qualified contractor.

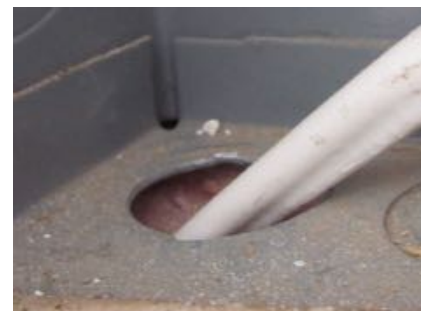
3- Electric wire coming in through the bottom of the panel is not protected with a wire clamp or anti-fray bushing. One should be installed.↓

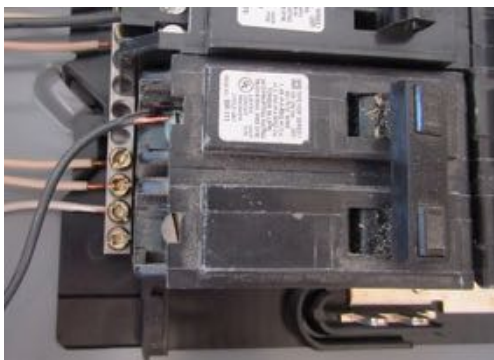
4- The 30-amp breaker in the bottom left corner of the panel is oversized for the wire used. And appropriately sized breaker should be installed. This is a potential fire hazard. ↓

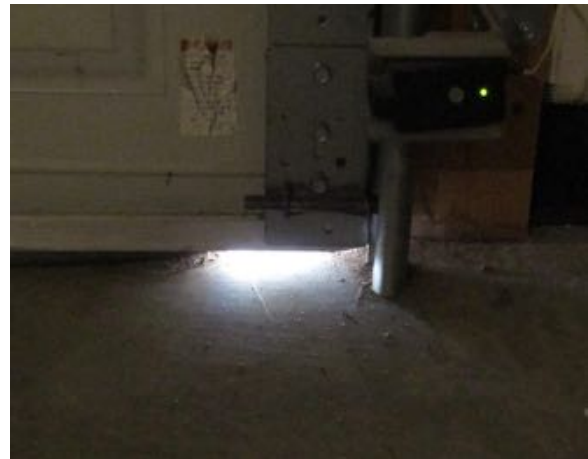
4- The garage door gasket appeared damaged. It should be replaced. →
